## QAF Meat Industries- Piggery

**Project:** Corrosion Protection  
**Category:** Commercial Linings  
**Completion Date:** Mid 2007  
**Product:** Tuff Stuff and Aliphatic Top Coat

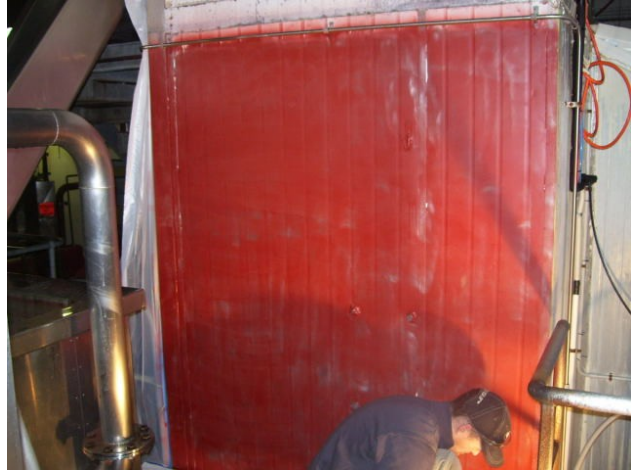
**BEFORE**

The Corowa based Piggery is one of the largest in the southern hemisphere. Continual wash down procedures for food safety identified the early onset of corrosion in some production areas.

Once identified, these areas were isolated, ground back to the original substrate and primed with RhinoPrime 251 and RL315.

Rhino Linings Tuff Stuff, pigmented in white was applied at approximately 2mm thick. A white Aliphatic Top Coat was then applied to remove any possible colour change due to the use of harsh cleaning compounds. This area was Completed on a single day over the weekend.
