## Water Storage Tank

**Project:** Paspaley Pearls

**Category:** Primary Containment –  
Potable Water

**Product:** Rhino Linings Tuff Stuff

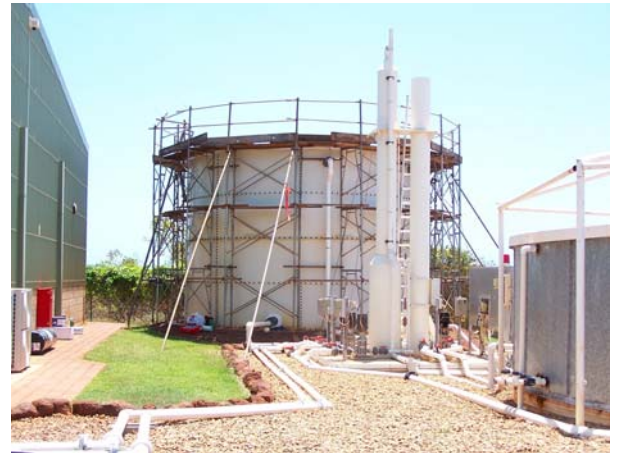
Paspaley required replacement of a damaged liner in a tank which was previously used to store seawater for the culture of pearls. They required a product that was suitable for potable water and Rhino Linings Tuff Stuff was the answer to their problem.

The tank was 4.7 mtr high, the roof needed to be removed and the internals sand blasted before applying the material. The tank was sprayed in Tuff Stuff with a geotextile floor base.
